REFURBISHMENT & PRE-DEMOLITION **ASBESTOS REPORT** **AND** **ASBESTOS REGISTER**

**Tobacco Warehouse
Regent Road
Liverpool
L3 0AN**

**Date Surveyed:
15/02/2017**

Ref: NM17472_01

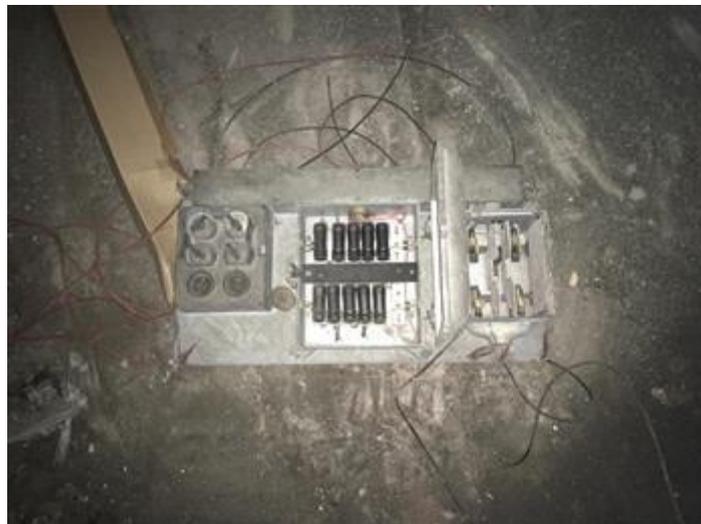
Abercorn Construction			
Project Ref		Building	Tobacco Warehouse
Location No	033	Floor	10th Floor
Position Description	Asbestos cement panels and asbestos paper behind fuses within electric units to floor by Stairwell 3	Room Number	Common Areas
		Asbestos Suspected

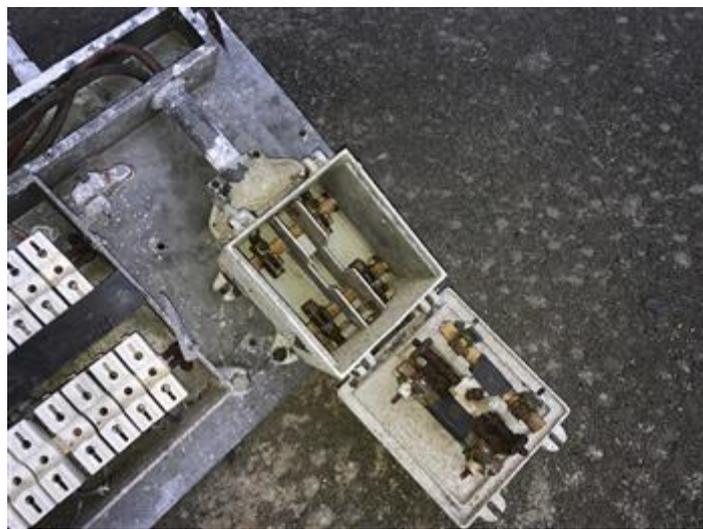
Abercorn Construction			
Project Ref		Building	Tobacco Warehouse
Location No	003	Floor	12th Floor
Position Description	Asbestos cement panels within electric units to floor	Room Number	Common Areas
		Asbestos Suspected

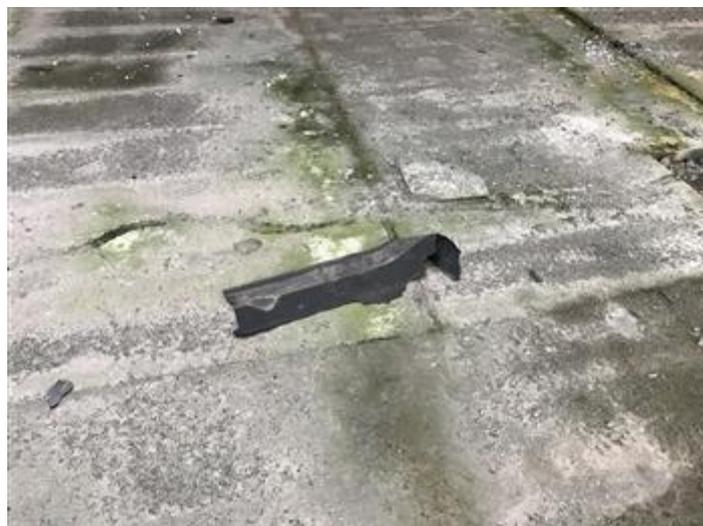
Abercorn Construction			
Project Ref		Building	Tobacco Warehouse
Location No	004	Floor	12th Floor
Position Description	Roof felt debris to floor	Room Number	Common Areas
		Asbestos Suspected	No

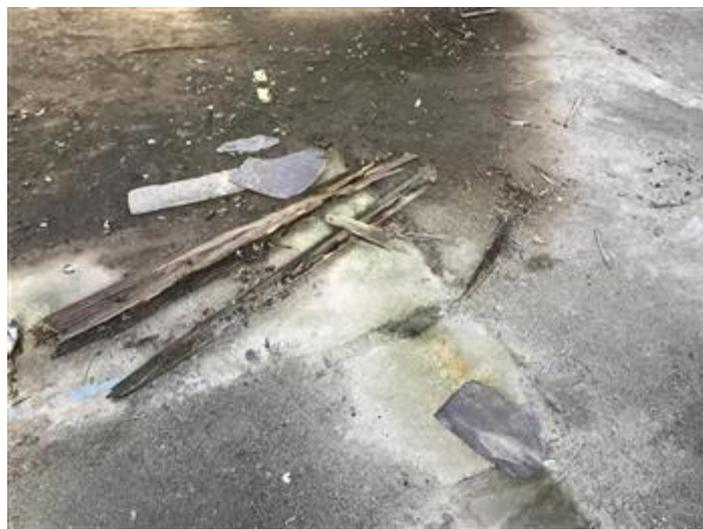
Abercorn Construction			
Project Ref		Building	Tobacco Warehouse
Location No	005	Floor	12th Floor
Position Description	Roof slate debris to floor	Room Number	Common Areas
		Asbestos Suspected	No

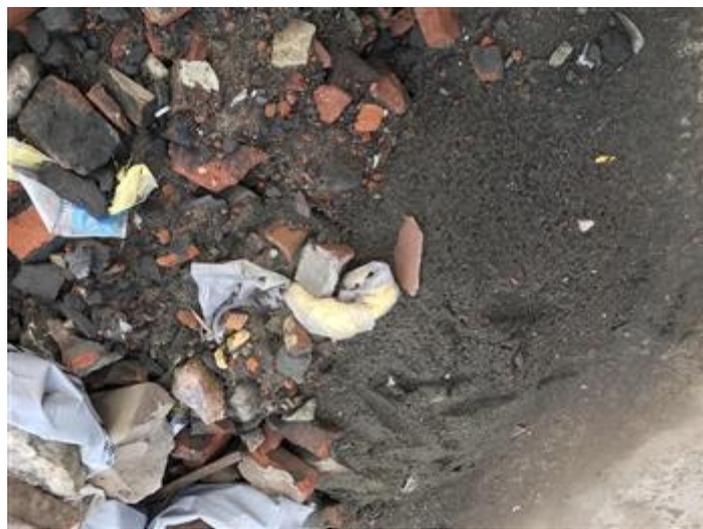
Abercorn Construction			
Project Ref		Building	Tobacco Warehouse
Location No	006	Floor	12th Floor
Position Description	Asbestos millboard debris to floor outside Stairwell 1	Room Number	Common Areas
		Asbestos Suspected

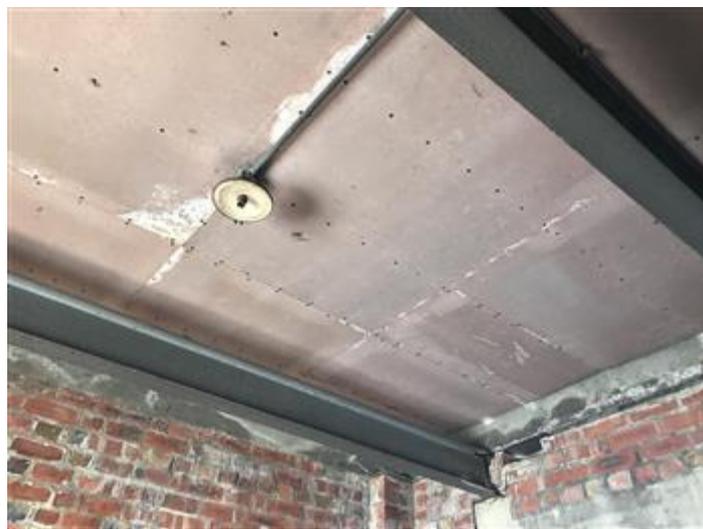
Abercorn Construction			
Project Ref		Building	Tobacco Warehouse
Location No	018	Floor	12th Floor
Position Description	Asbestos millboard underlining to roof	Room Number	Lift Shaft 1 Lift Motor Room
		Asbestos Suspected

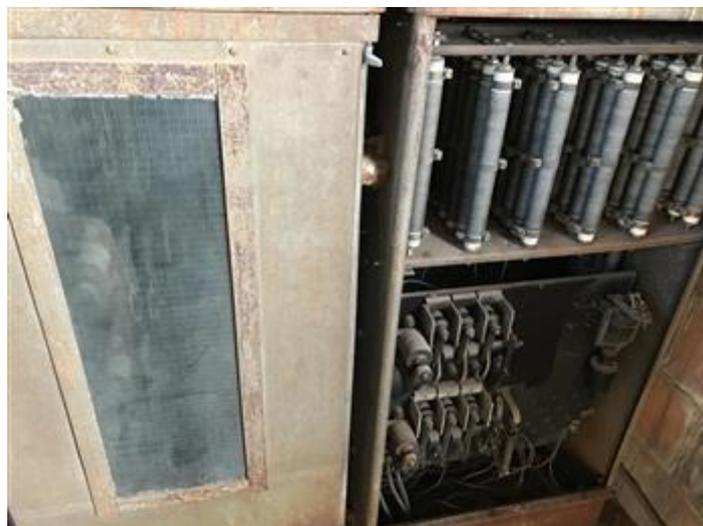
Abercorn Construction			
Project Ref		Building	Tobacco Warehouse
Location No	019	Floor	12th Floor
Position Description	Asbestos panel to rear of large electric units	Room Number	Lift Shaft 1 Lift Motor Room
		Asbestos Suspected

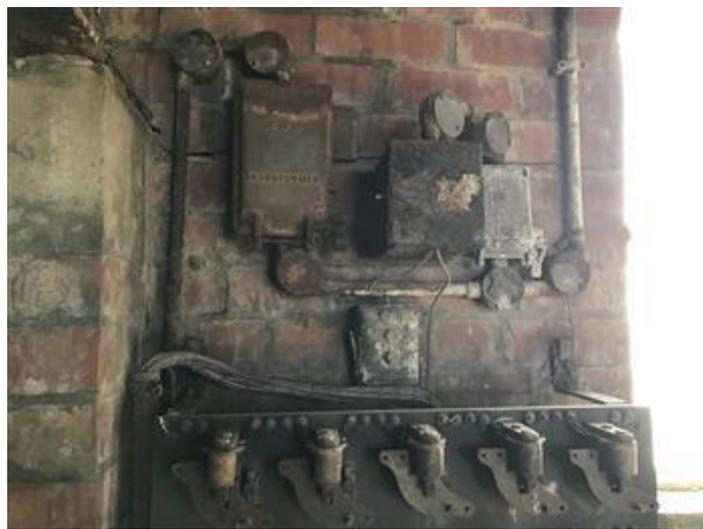
Abercorn Construction			
Project Ref		Building	Tobacco Warehouse
Location No	020	Floor	12th Floor
Position Description	Electric switchgear units - typical throughout building	Room Number	Lift Shaft 1 Lift Motor Room
		Asbestos Suspected

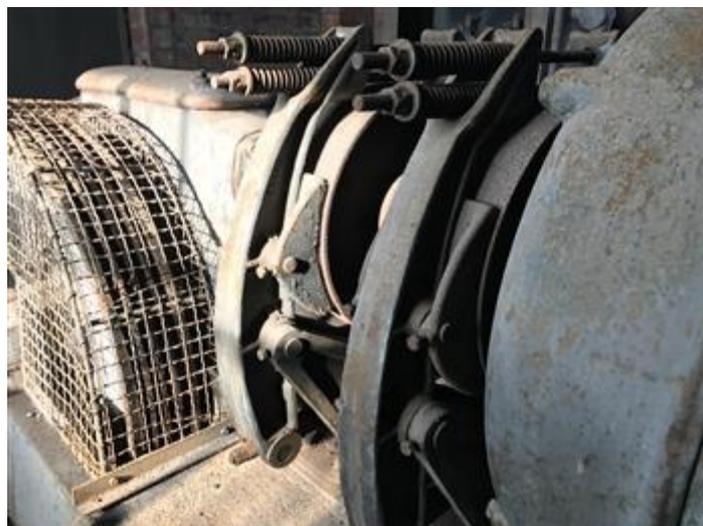
Abercorn Construction			
Project Ref		Building	Tobacco Warehouse
Location No	021	Floor	12th Floor
Position Description	Asbestos brake shoes to lift motor	Room Number	Lift Shaft 1 Lift Motor Room
		Asbestos Suspected

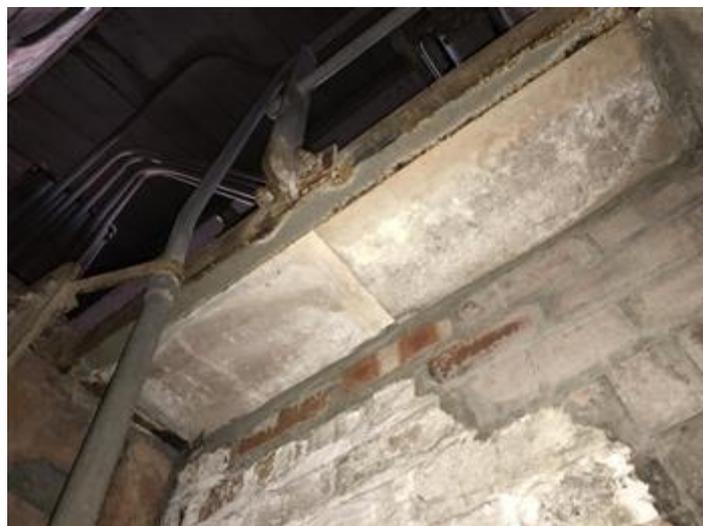
Abercorn Construction			
Project Ref		Building	Tobacco Warehouse
Location No	022	Floor	12th Floor
Position Description	Asbestos millboard soffit to ladder access	Room Number	Lift Shaft 1 Lift Motor Room
		Asbestos Suspected

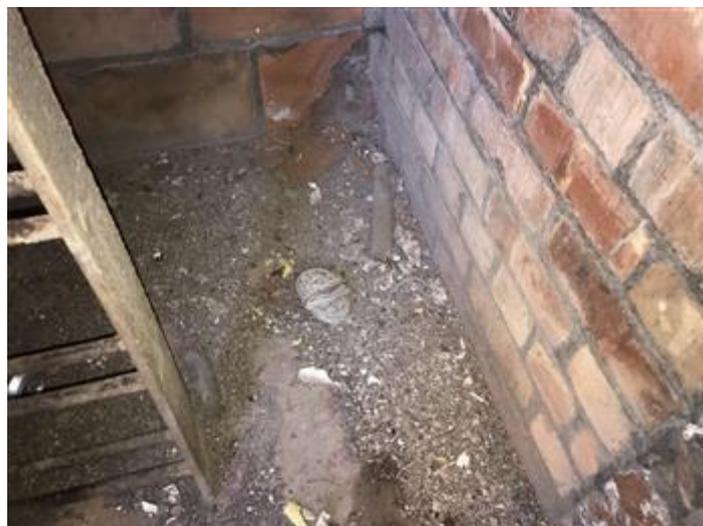
Abercorn Construction			
Project Ref		Building	Tobacco Warehouse
Location No	023	Floor	12th Floor
Position Description	Rope debris to floor of ladder access	Room Number	Lift Shaft 1 Lift Motor Room
		Asbestos Suspected	No

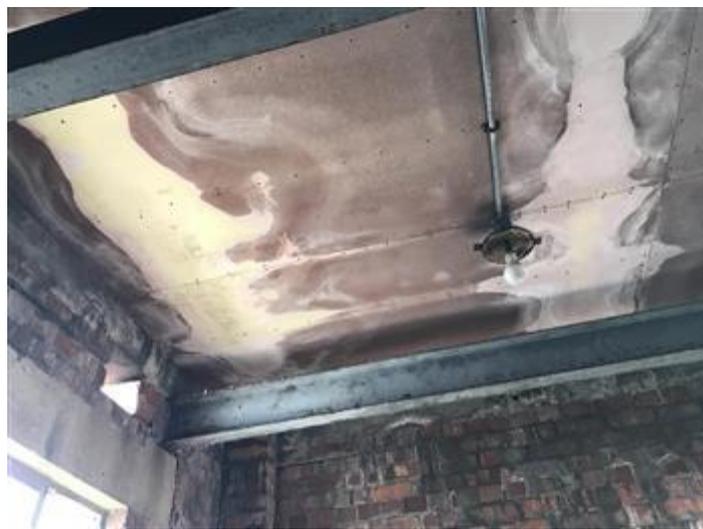
Abercorn Construction			
Project Ref		Building	Tobacco Warehouse
Location No	024	Floor	12th Floor
Position Description	Asbestos millboard underlining to roof	Room Number	Lift Shaft 2 Lift Motor Room
		Asbestos Suspected

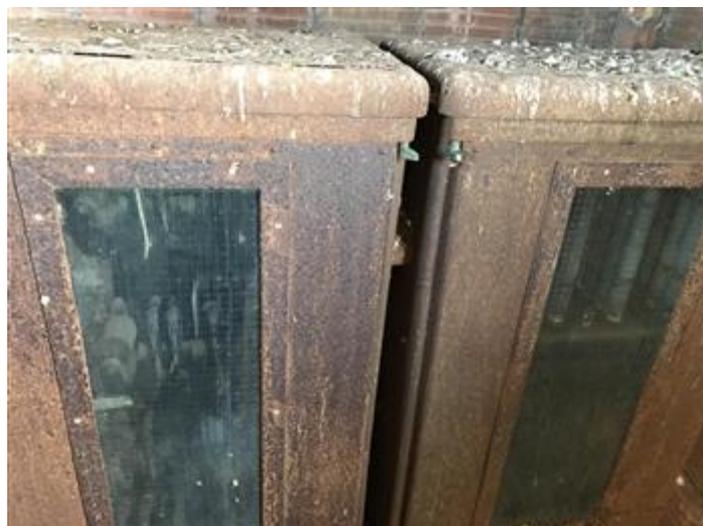
Abercorn Construction			
Project Ref		Building	Tobacco Warehouse
Location No	025	Floor	12th Floor
Position Description	Asbestos panel to rear of large electric units	Room Number	Lift Shaft 2 Lift Motor Room
		Asbestos Suspected

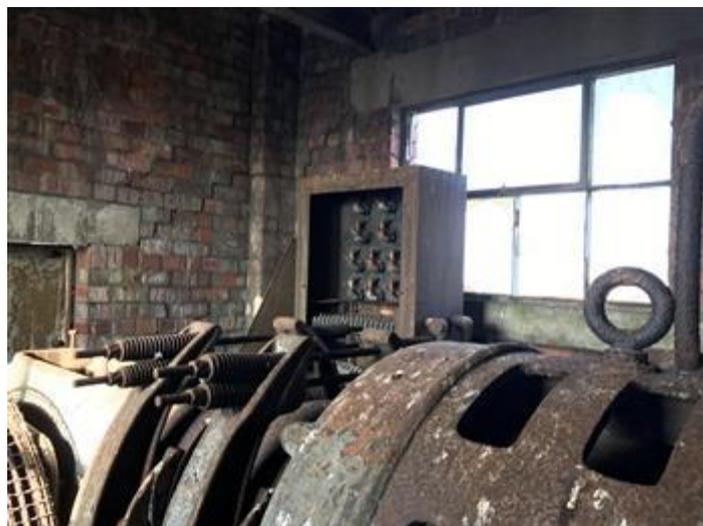
Abercorn Construction			
Project Ref		Building	Tobacco Warehouse
Location No	027	Floor	12th Floor
Position Description	Asbestos brake shoes to lift motor	Room Number	Lift Shaft 2 Lift Motor Room
		Asbestos Suspected

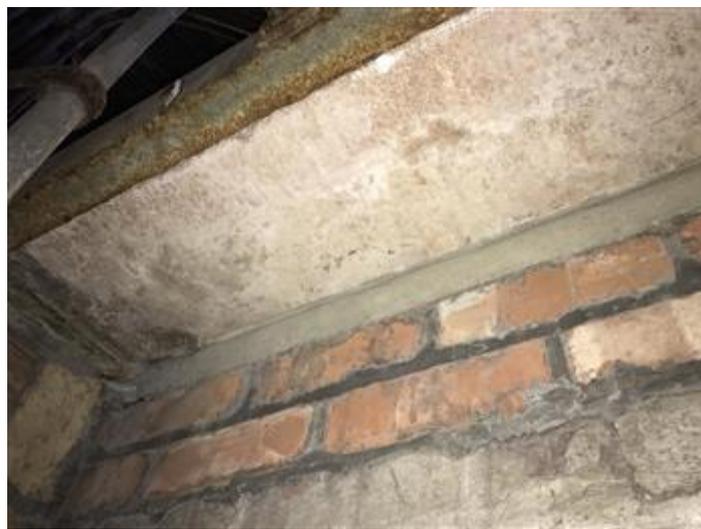
Abercorn Construction			
Project Ref		Building	Tobacco Warehouse
Location No	028	Floor	12th Floor
Position Description	Asbestos millboard soffit to ladder access	Room Number	Lift Shaft 2 Lift Motor Room
		Asbestos Suspected
