REFURBISHMENT & PRE-DEMOLITION **ASBESTOS REPORT** **AND** **ASBESTOS REGISTER**

**Tobacco Warehouse
Regent Road
Liverpool
L3 0AN**

**Date Surveyed:
15/02/2017**

Ref: NM17472_01

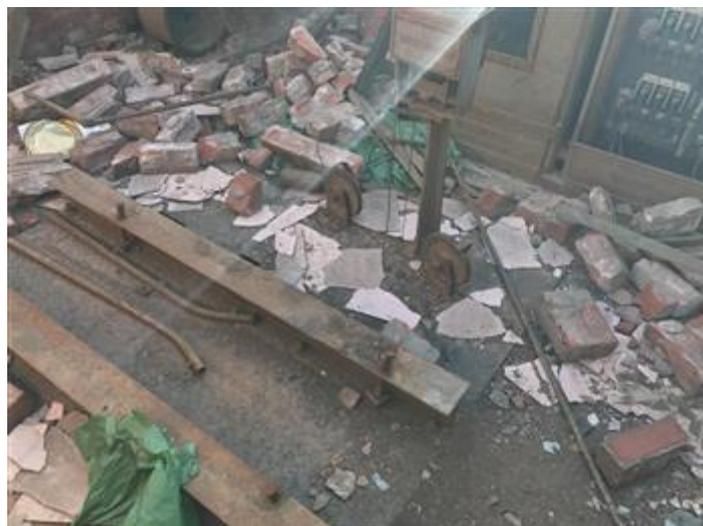
Abercorn Construction			
Project Ref		Building	Tobacco Warehouse
Location No	007	Floor	12th Floor
Position Description	Asbestos millboard debris to floor	Room Number	Stairwell 1 Lift Motor Room
		Asbestos Suspected

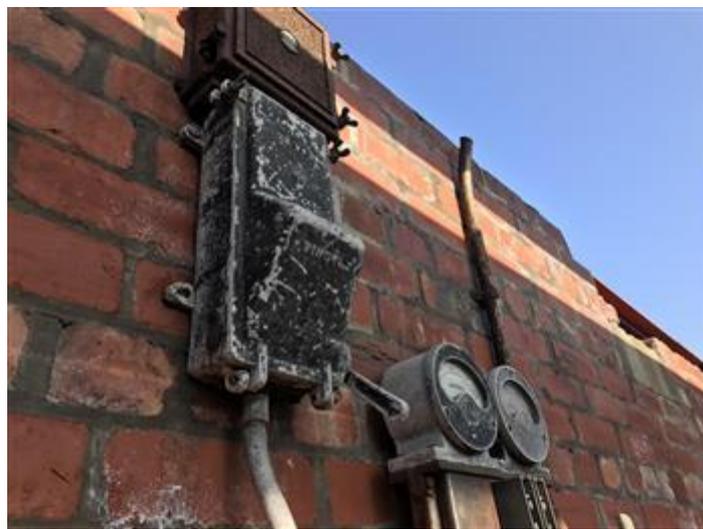
Abercorn Construction			
Project Ref		Building	Tobacco Warehouse
Location No	008	Floor	12th Floor
Position Description	Electric switchgear units - typical throughout building	Room Number	Stairwell 1 Lift Motor Room
		Asbestos Suspected

Comments:	- Removed by Nationwide Asbestos Management Ltd
Recommendations:	-

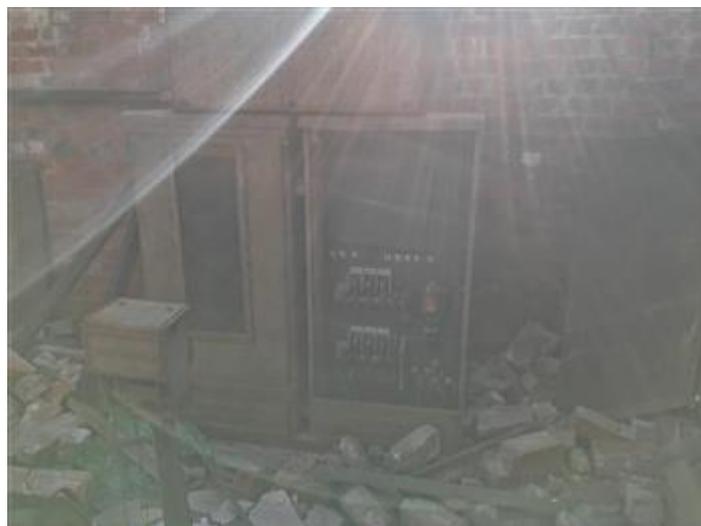
Abercorn Construction			
Project Ref		Building	Tobacco Warehouse
Location No	009	Floor	12th Floor
Position Description	Asbestos panel to rear of large electric units	Room Number	Stairwell 1 Lift Motor Room
		Asbestos Suspected

Comments:	- Removed by Nationwide Asbestos Management Ltd
Recommendations:	-

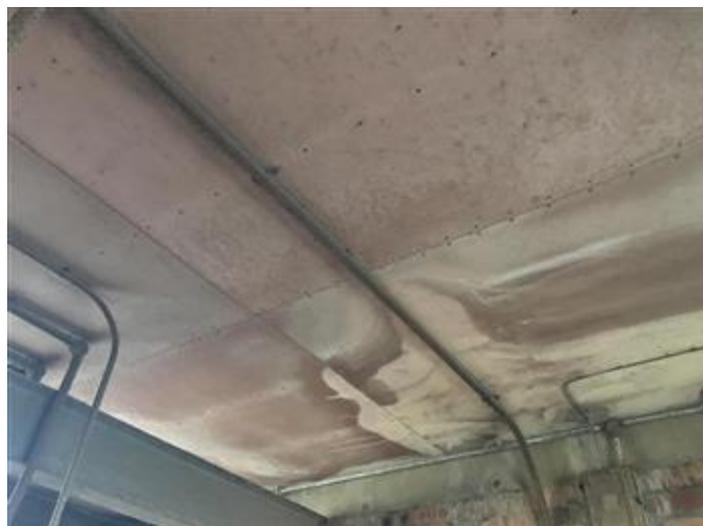
Abercorn Construction			
Project Ref		Building	Tobacco Warehouse
Location No	010	Floor	12th Floor
Position Description	Asbestos millboard underlining to roof	Room Number	Stairwell 2 Lift Motor Room
		Asbestos Suspected

Comments:	- Removed by Green Contract Services
Recommendations:	-

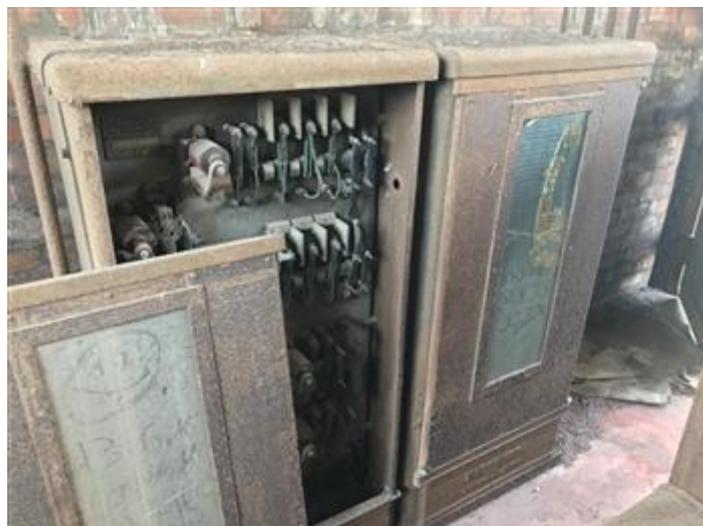
Abercorn Construction			
Project Ref		Building	Tobacco Warehouse
Location No	011	Floor	12th Floor
Position Description	Asbestos panel to rear of large electric units	Room Number	Stairwell 2 Lift Motor Room
		Asbestos Suspected

Comments:	- Removed by Nationwide Asbestos Management Ltd
Recommendations:	-

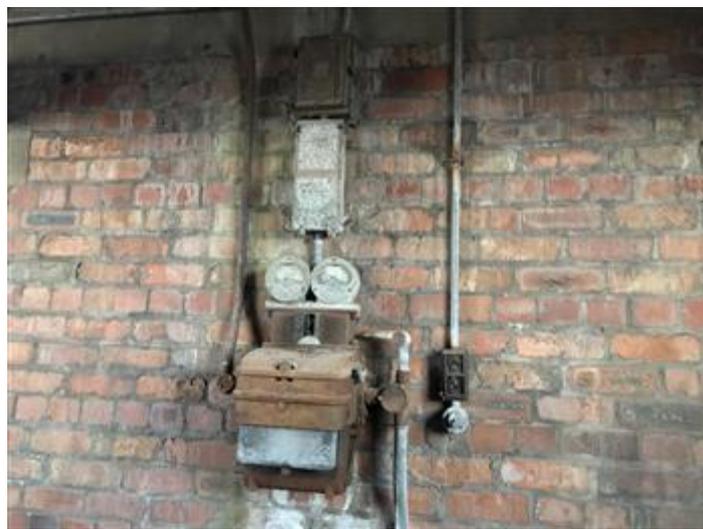
Abercorn Construction			
Project Ref		Building	Tobacco Warehouse
Location No	012	Floor	12th Floor
Position Description	Electric switchgear units - typical throughout building	Room Number	Stairwell 2 Lift Motor Room
		Asbestos Suspected

Comments:	- Removed by Nationwide Asbestos Management Ltd
Recommendations:	-

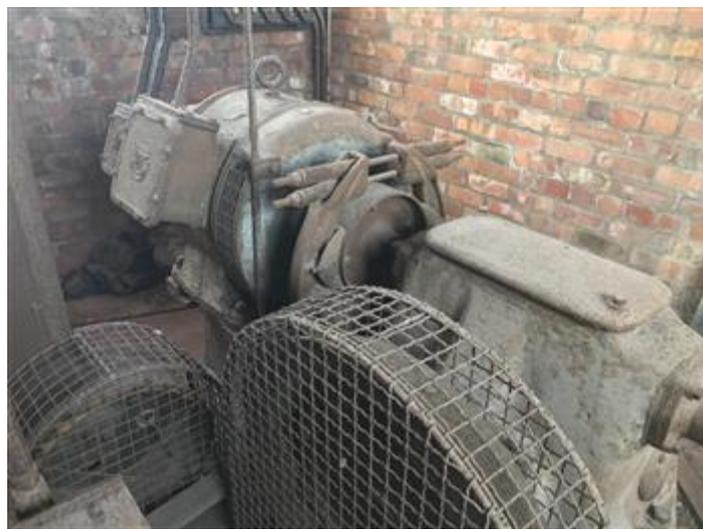
Abercorn Construction			
Project Ref		Building	Tobacco Warehouse
Location No	013	Floor	12th Floor
Position Description	Asbestos brake shoes to lift motor	Room Number	Stairwell 2 Lift Motor Room
		Asbestos Suspected

Comments:	- Removed by Nationwide Asbestos Management Ltd
Recommendations:	-

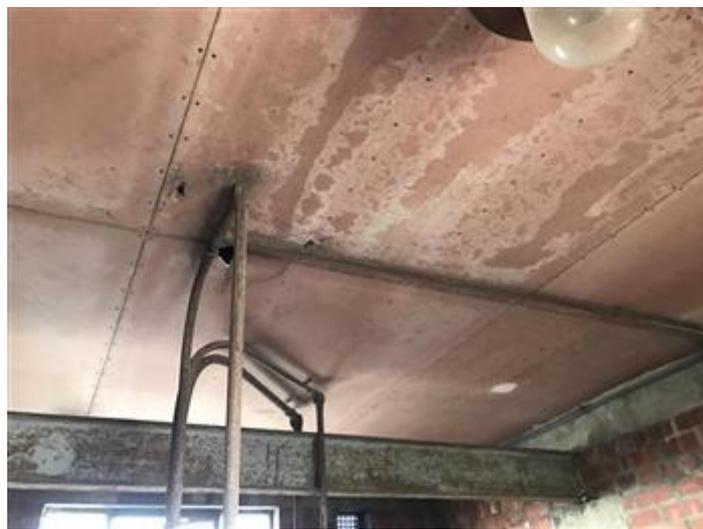
Abercorn Construction			
Project Ref		Building	Tobacco Warehouse
Location No	014	Floor	12th Floor
Position Description	Asbestos millboard underlining to roof	Room Number	Stairwell 3 Lift Motor Room
		Asbestos Suspected

Comments:	- Removed by Green Contract Services
Recommendations:	-

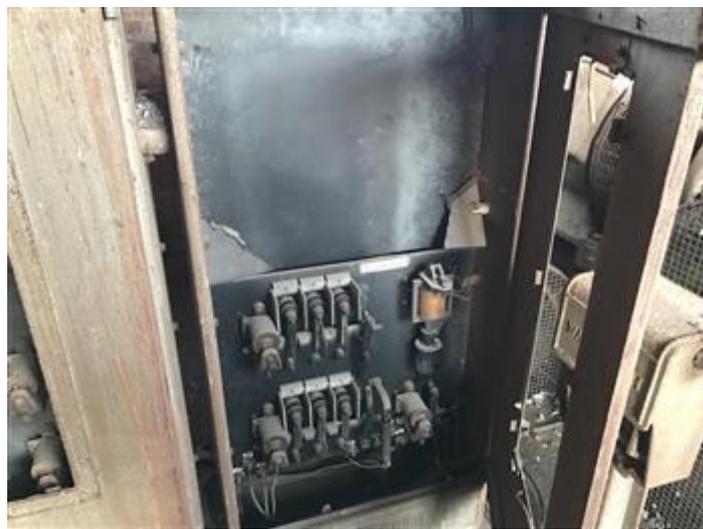
Abercorn Construction			
Project Ref		Building	Tobacco Warehouse
Location No	015	Floor	12th Floor
Position Description	Asbestos panel to rear of large electric units	Room Number	Stairwell 3 Lift Motor Room
		Asbestos Suspected

Comments:	- Removed by Nationwide Asbestos Management Ltd
Recommendations:	-

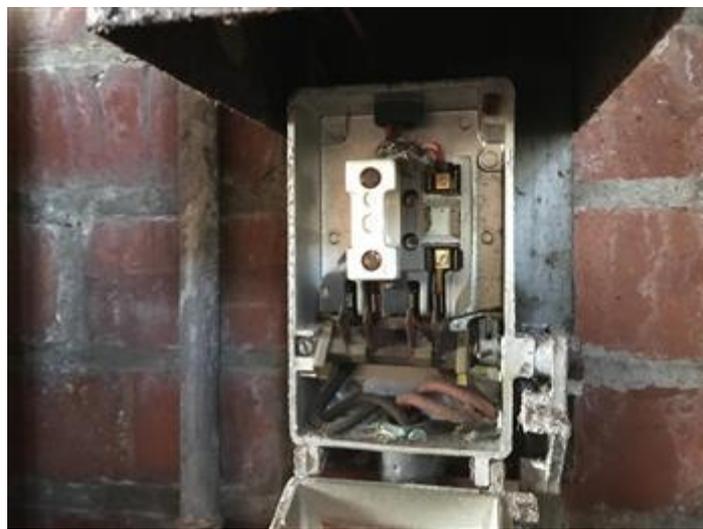
Abercorn Construction			
Project Ref		Building	Tobacco Warehouse
Location No	016	Floor	12th Floor
Position Description	Electric switchgear units - typical throughout building	Room Number	Stairwell 3 Lift Motor Room
		Asbestos Suspected

Comments:	- Removed by Nationwide Asbestos Management Ltd
Recommendations:	-

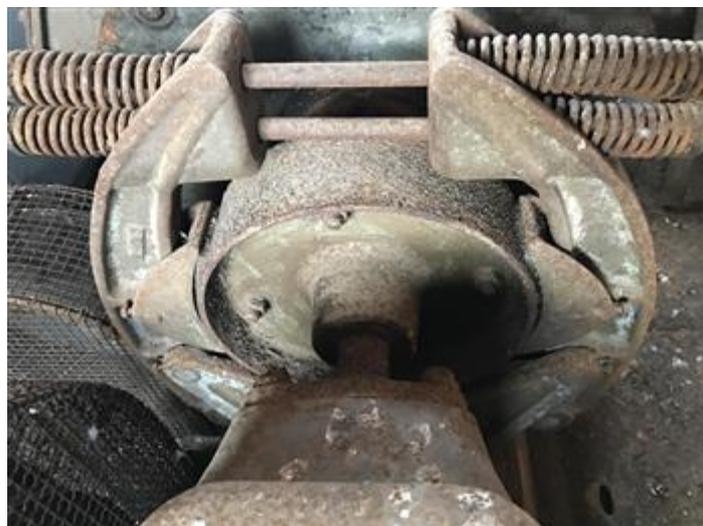
Abercorn Construction			
Project Ref		Building	Tobacco Warehouse
Location No	017	Floor	12th Floor
Position Description	Asbestos brake shoes to lift motor	Room Number	Stairwell 3 Lift Motor Room
		Asbestos Suspected

Comments:	- Removed by Nationwide Asbestos Management Ltd
Recommendations:	-

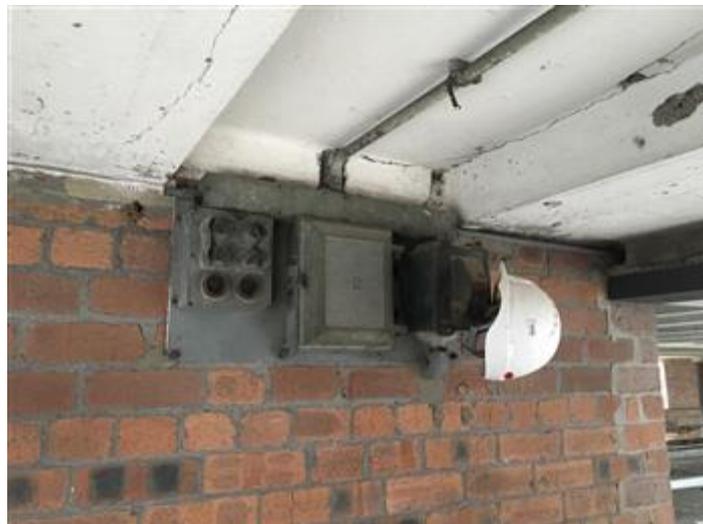
Abercorn Construction			
Project Ref		Building	Tobacco Warehouse
Location No	044	Floor	5th Floor
Position Description	Asbestos cement panels and asbestos paper behind fuses within electric units to wall by Stairwell 2	Room Number	Common Areas
		Asbestos Suspected

Comments:	- Removed by Nationwide Asbestos Management Ltd
Recommendations:	-

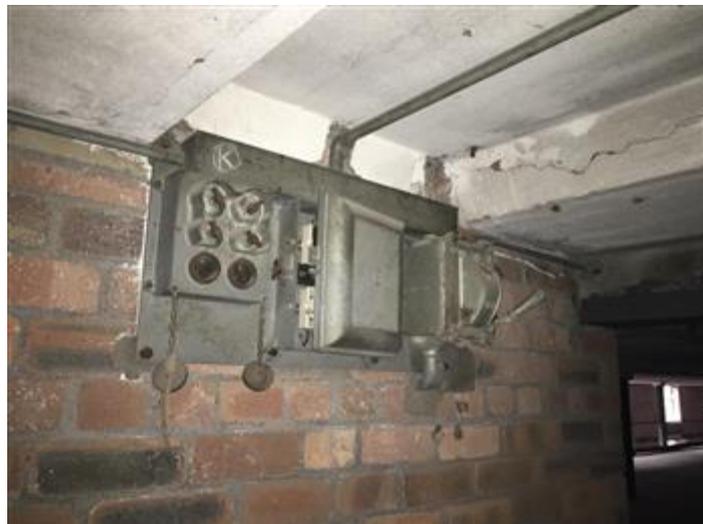
Abercorn Construction			
Project Ref		Building	Tobacco Warehouse
Location No	045	Floor	5th Floor
Position Description	Asbestos cement panels and asbestos paper behind fuses within electric units to wall by Stairwell 3	Room Number	Common Areas
		Asbestos Suspected

Comments:	- Removed by Nationwide Asbestos Management Ltd
Recommendations:	-

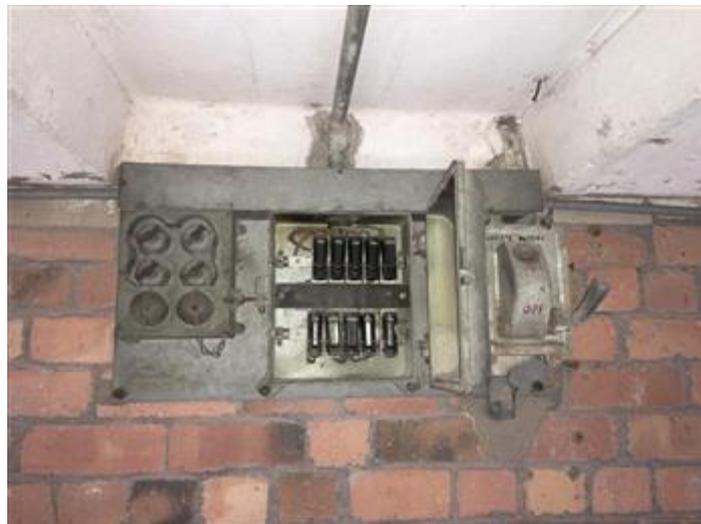
Abercorn Construction			
Project Ref		Building	Tobacco Warehouse
Location No	042	Floor	6th Floor
Position Description	Asbestos cement panels and asbestos paper behind fuses within electric units to wall by Stairwell 2	Room Number	Common Areas
		Asbestos Suspected

Comments:	- Removed by Nationwide Asbestos Management Ltd
Recommendations:	-

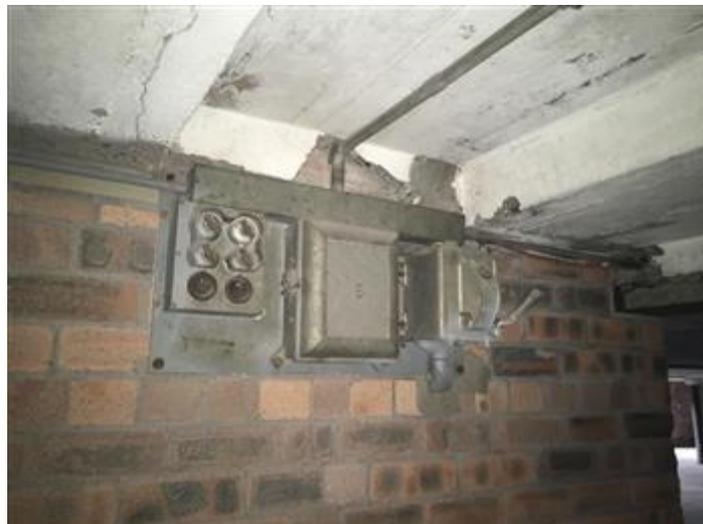
Abercorn Construction			
Project Ref		Building	Tobacco Warehouse
Location No	043	Floor	6th Floor
Position Description	Asbestos cement panels and asbestos paper behind fuses within electric units to wall by Stairwell 3	Room Number	Common Areas
		Asbestos Suspected

Comments:	- Removed by Nationwide Asbestos Management Ltd
Recommendations:	-

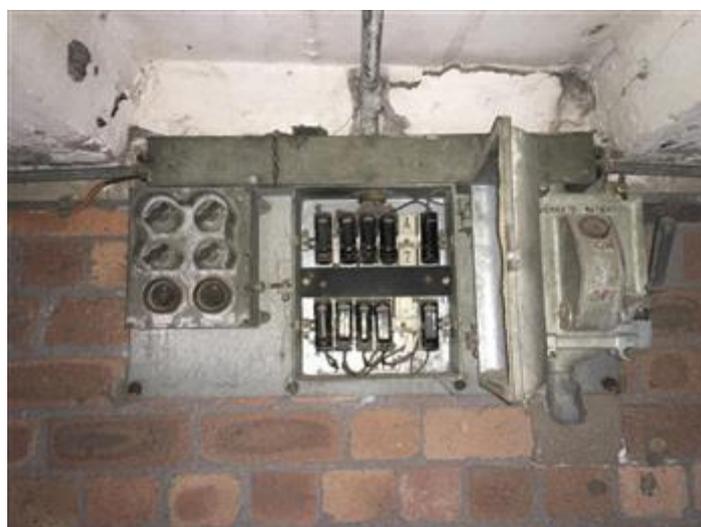
Abercorn Construction			
Project Ref		Building	Tobacco Warehouse
Location No	039	Floor	7th Floor
Position Description	Asbestos cement panels and asbestos paper behind fuses within electric units to wall by Stairwell 2	Room Number	Common Areas
		Asbestos Suspected

Comments:	- Removed by Nationwide Asbestos Management Ltd
Recommendations:	-

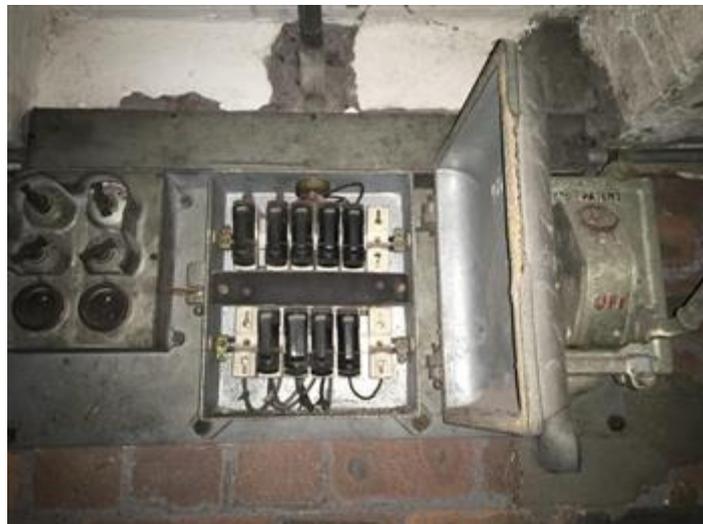
Abercorn Construction			
Project Ref		Building	Tobacco Warehouse
Location No	040	Floor	7th Floor
Position Description	Asbestos cement panels and asbestos paper behind fuses within electric units to wall by Stairwell 3	Room Number	Common Areas
		Asbestos Suspected

Comments:	- Removed by Nationwide Asbestos Management Ltd
Recommendations:	-

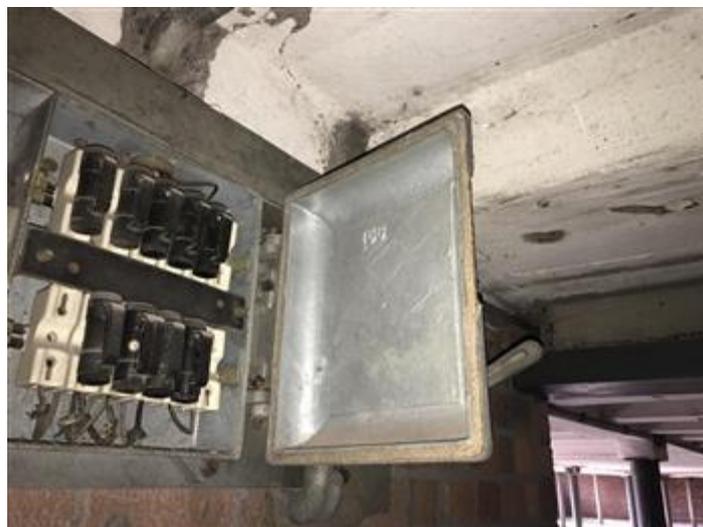
Abercorn Construction			
Project Ref		Building	Tobacco Warehouse
Location No	041	Floor	7th Floor
Position Description	Non-asbestos rope to electric box door by Stairwell 3 - Typical throughout	Room Number	Common Areas
		Asbestos Suspected	No

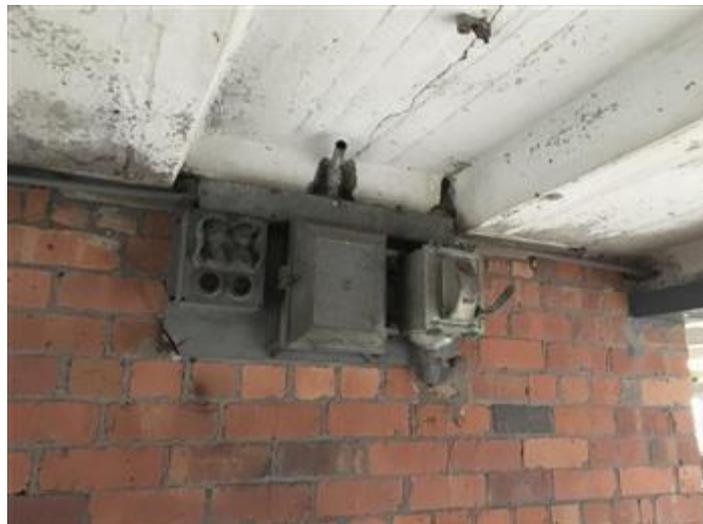
Abercorn Construction			
Project Ref		Building	Tobacco Warehouse
Location No	037	Floor	8th Floor
Position Description	Asbestos cement panels and asbestos paper behind fuses within electric units to wall by Stairwell 2	Room Number	Common Areas
		Asbestos Suspected

Comments:	- Removed by Nationwide Asbestos Management Ltd
Recommendations:	-

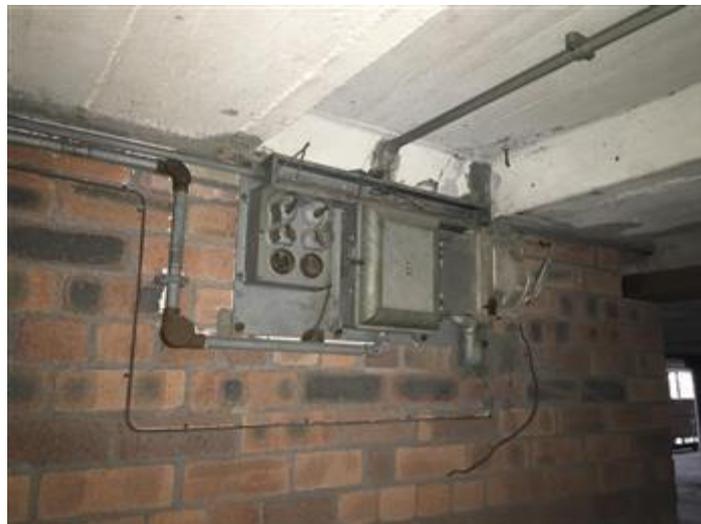
Abercorn Construction			
Project Ref		Building	Tobacco Warehouse
Location No	038	Floor	8th Floor
Position Description	Asbestos cement panels and asbestos paper behind fuses within electric units to wall by Stairwell 3	Room Number	Common Areas
		Asbestos Suspected

Comments:	- Removed by Nationwide Asbestos Management Ltd
Recommendations:	-

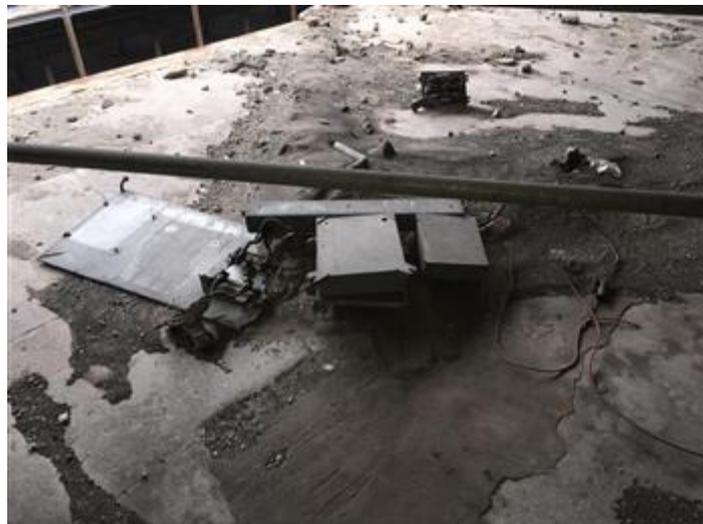
Abercorn Construction			
Project Ref		Building	Tobacco Warehouse
Location No	034	Floor	9th Floor
Position Description	Asbestos cement panels and asbestos paper behind fuses within electric units to floor by Stairwell 3	Room Number	Common Areas
		Asbestos Suspected

Comments:	- Removed by Nationwide Asbestos Management Ltd
Recommendations:	-

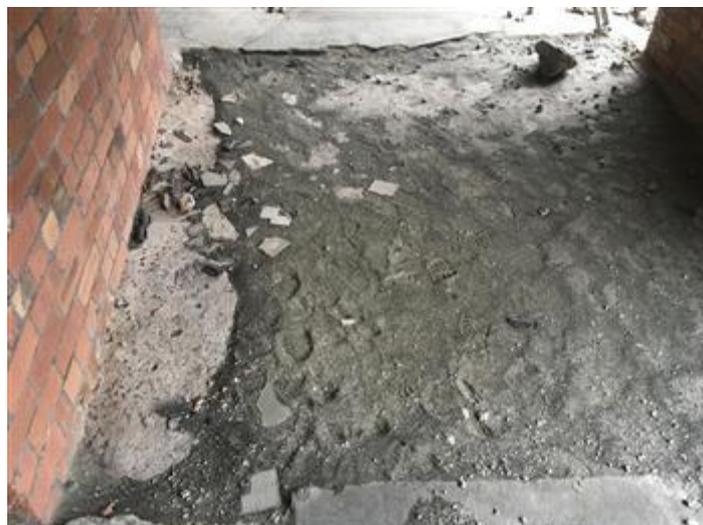
Abercorn Construction			
Project Ref		Building	Tobacco Warehouse
Location No	035	Floor	9th Floor
Position Description	Asbestos cement debris from electric units to floor of walkway by Stairwell 2	Room Number	Common Areas
		Asbestos Suspected

Comments:	- Removed by Nationwide Asbestos Management Ltd
Recommendations:	-

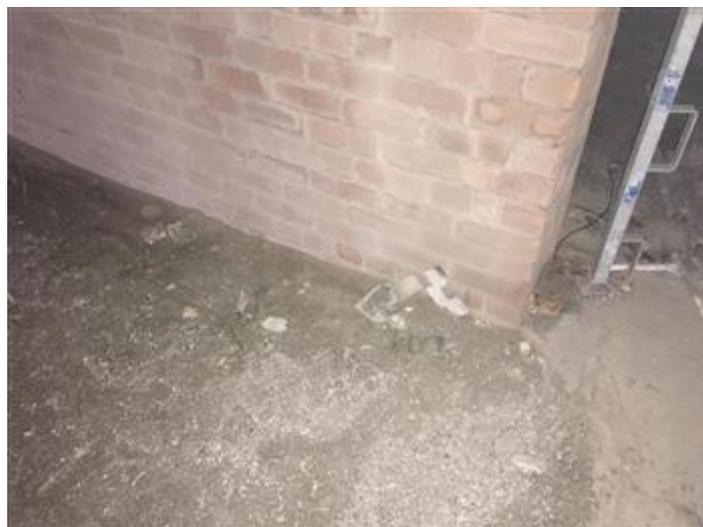
Abercorn Construction			
Project Ref		Building	Tobacco Warehouse
Location No	036	Floor	9th Floor
Position Description	Asbestos cement debris from electric units to floor of walkway by Stairwell 3	Room Number	Common Areas
		Asbestos Suspected

Comments:	- Removed by Nationwide Asbestos Management Ltd
Recommendations:	-

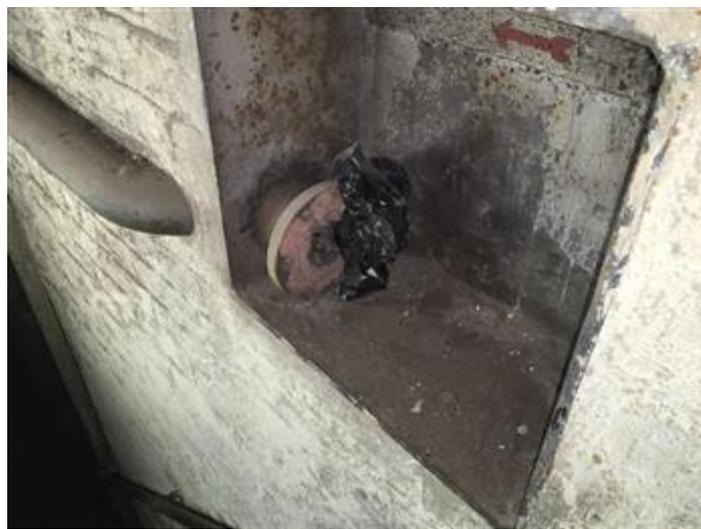
Abercorn Construction			
Project Ref		Building	Tobacco Warehouse
Location No	030	Floor	All Floors
Position Description	Gasket residue to pipe joint on 1st floor - typical throughout	Room Number	Stairwell 1
		Asbestos Suspected	No

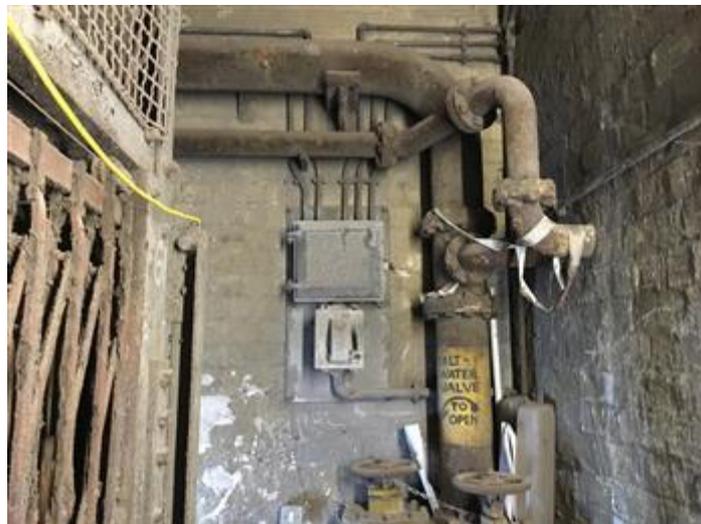
Abercorn Construction			
Project Ref		Building	Tobacco Warehouse
Location No	045	Floor	All Floors
Position Description	Asbestos cement panels and asbestos paper behind fuses within electric units to wall on ground floor	Room Number	Stairwell 1
		Asbestos Suspected

Comments:	- Removed by Nationwide Asbestos Management Ltd
Recommendations:	-

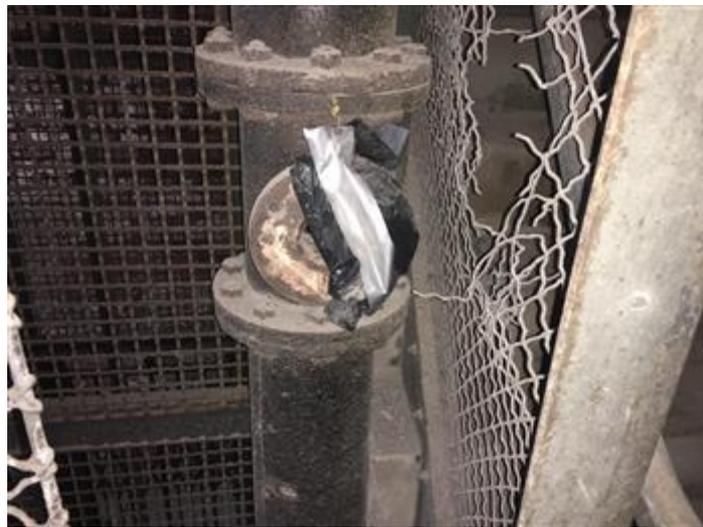
Abercorn Construction			
Project Ref		Building	Tobacco Warehouse
Location No	031	Floor	All Floors
Position Description	Gasket residue to pipe joint on 10th floor - typical throughout	Room Number	Stairwell 2
		Asbestos Suspected	No

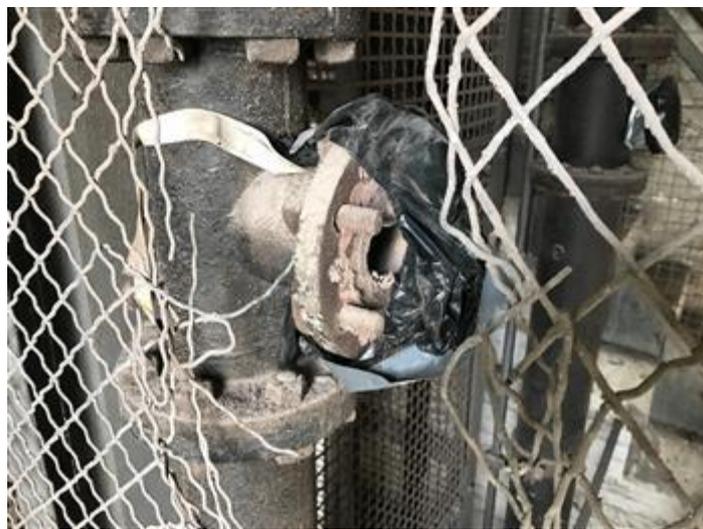
Abercorn Construction			
Project Ref		Building	Tobacco Warehouse
Location No	032	Floor	All Floors
Position Description	Gasket residue to pipe joint on 8th floor - typical throughout	Room Number	Stairwell 3
		Asbestos Suspected	No

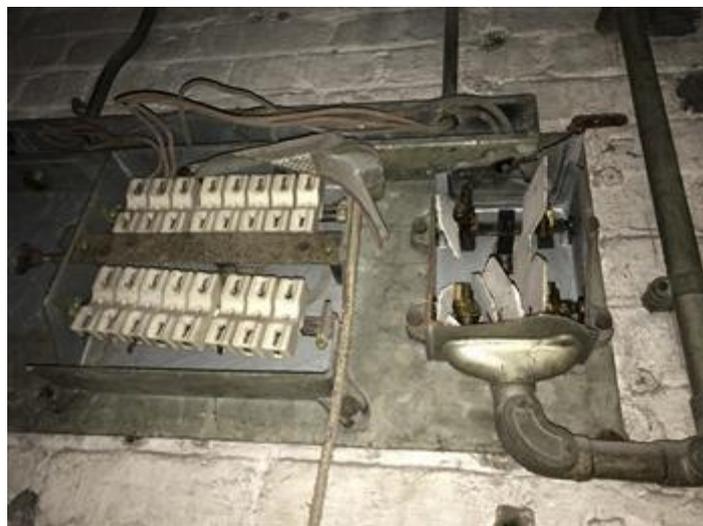
Abercorn Construction			
Project Ref		Building	Tobacco Warehouse
Location No	049	Floor	Basement
Position Description	Asbestos cement panels and asbestos paper behind fuses within electric units to walkways in basement - typical throughout basement	Room Number	Common Areas
		Asbestos Suspected

Comments:	- Removed by Nationwide Asbestos Management Ltd
Recommendations:	-

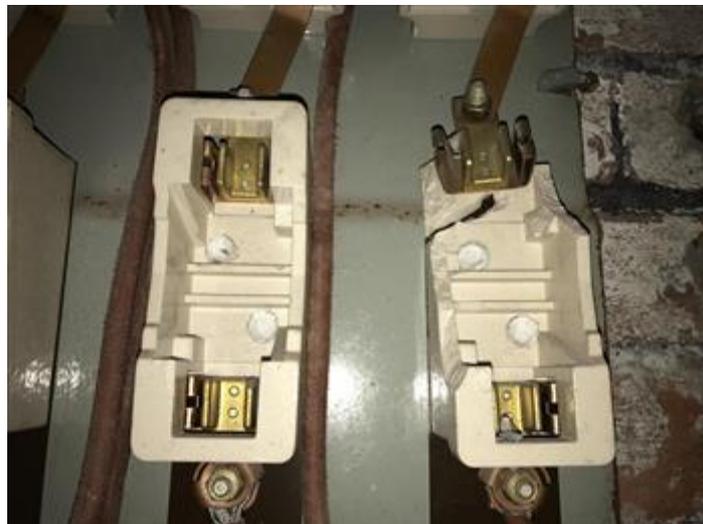
Abercorn Construction			
Project Ref		Building	Tobacco Warehouse
Location No	050	Floor	Basement
Position Description	Asbestos paper insulation to rear of fuse holders on metal screw heads - typical throughout basement	Room Number	Common Areas
		Asbestos Suspected

Comments:	- Removed by Nationwide Asbestos Management Ltd
Recommendations:	-

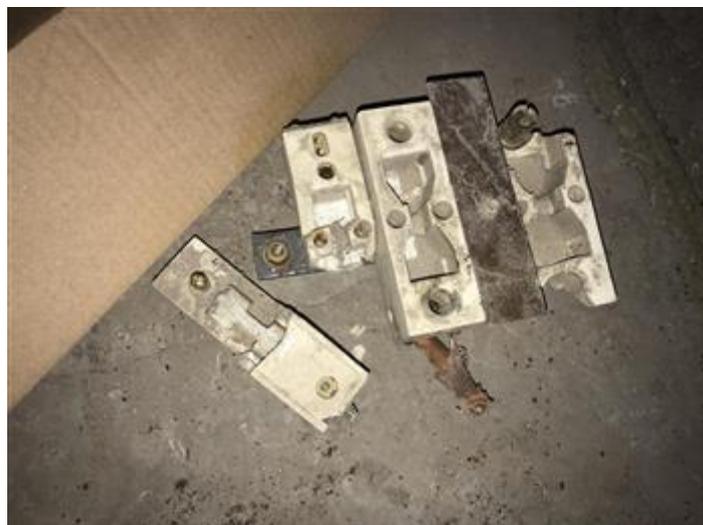
Abercorn Construction			
Project Ref		Building	Tobacco Warehouse
Location No	051	Floor	Basement
Position Description	Asbestos rope insulation to fuse - typical throughout basement	Room Number	Common Areas
		Asbestos Suspected

Comments:	- Removed by Nationwide Asbestos Management Ltd
Recommendations:	-

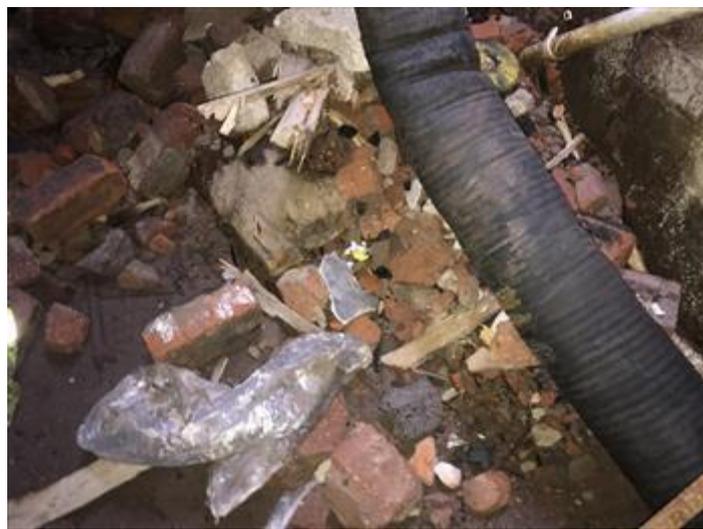
Abercorn Construction			
Project Ref		Building	Tobacco Warehouse
Location No	052	Floor	Basement
Position Description	Non-asbestos boarding to floor in debris by Stairwell 1	Room Number	Common Areas
		Asbestos Suspected	No

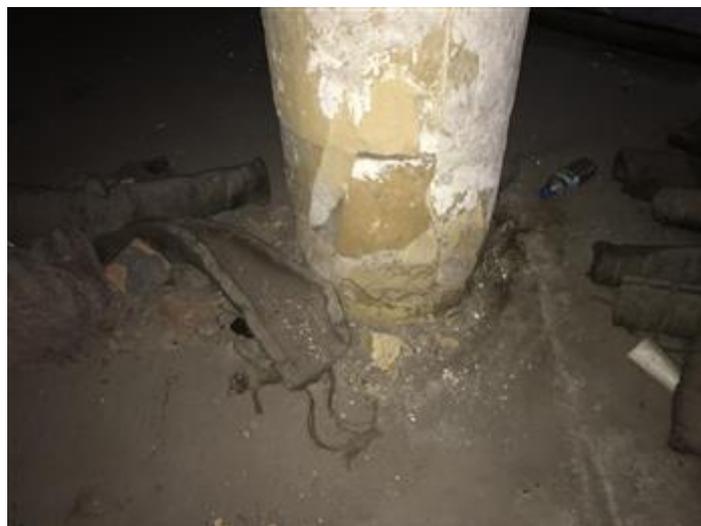
Abercorn Construction			
Project Ref		Building	Tobacco Warehouse
Location No	053	Floor	Basement
Position Description	Cementitious cladding to columns - typical throughout	Room Number	Common Areas
		Asbestos Suspected	No

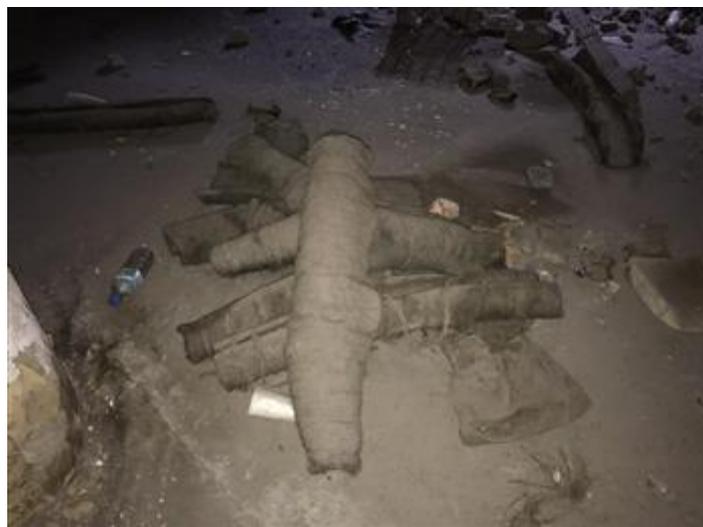
Abercorn Construction			
Project Ref		Building	Tobacco Warehouse
Location No	054	Floor	Basement
Position Description	Hessian rope pipe insulation to floor - typical throughout basement and on pipes	Room Number	Common Areas
		Asbestos Suspected	No

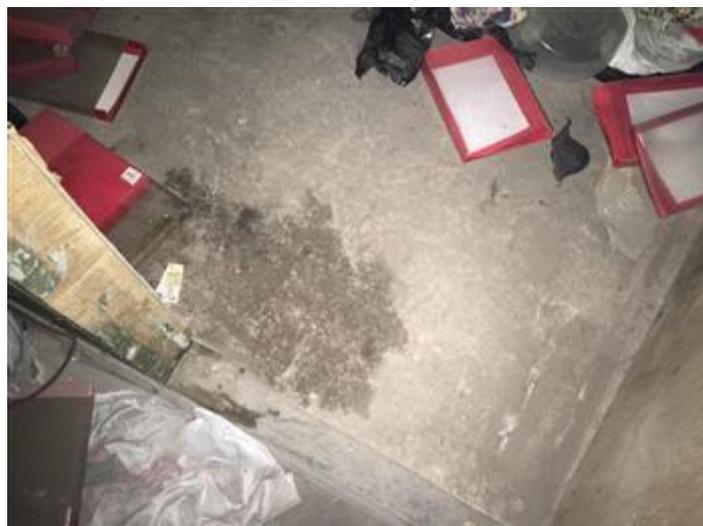
Abercorn Construction			
Project Ref		Building	Tobacco Warehouse
Location No	046	Floor	Ground Floor
Position Description	New vinyl flooring in office between stairwell 2 & 3	Room Number	Common Areas
		Asbestos Suspected	No

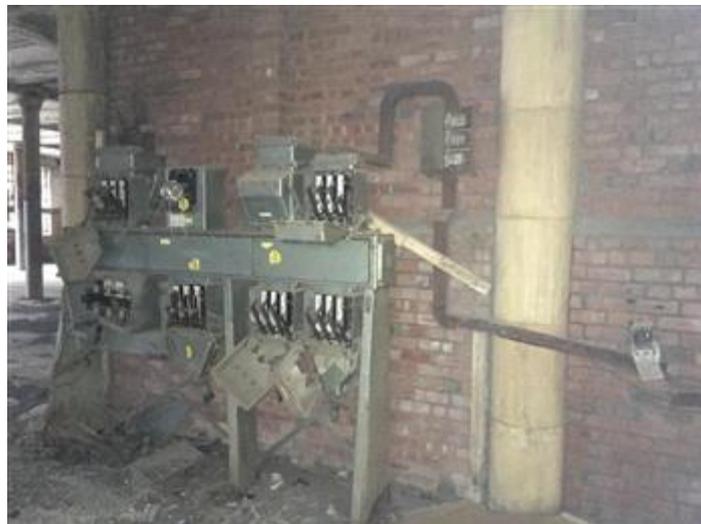
Abercorn Construction			
Project Ref		Building	Tobacco Warehouse
Location No	047	Floor	Ground Floor
Position Description	Asbestos cement panels and asbestos paper behind fuses within electric units to various walls at East end of building	Room Number	Common Areas
		Asbestos Suspected

Comments:	- Removed by Nationwide Asbestos Management Ltd
Recommendations:	-
